# New Hampshire Volunteer Lake Assessment Program

## 2002 Bi-Annual Report for French Pond Henniker

NHDES  
Water Division  
Watershed Management Bureau  
6 Hazen Drive  
Concord, NH 03301

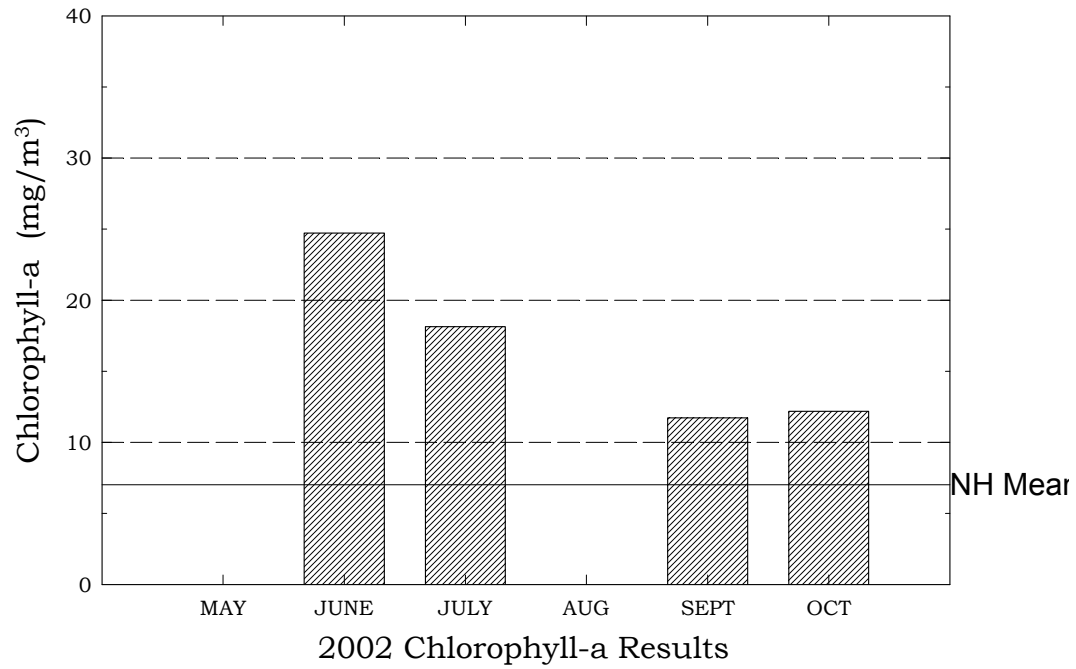
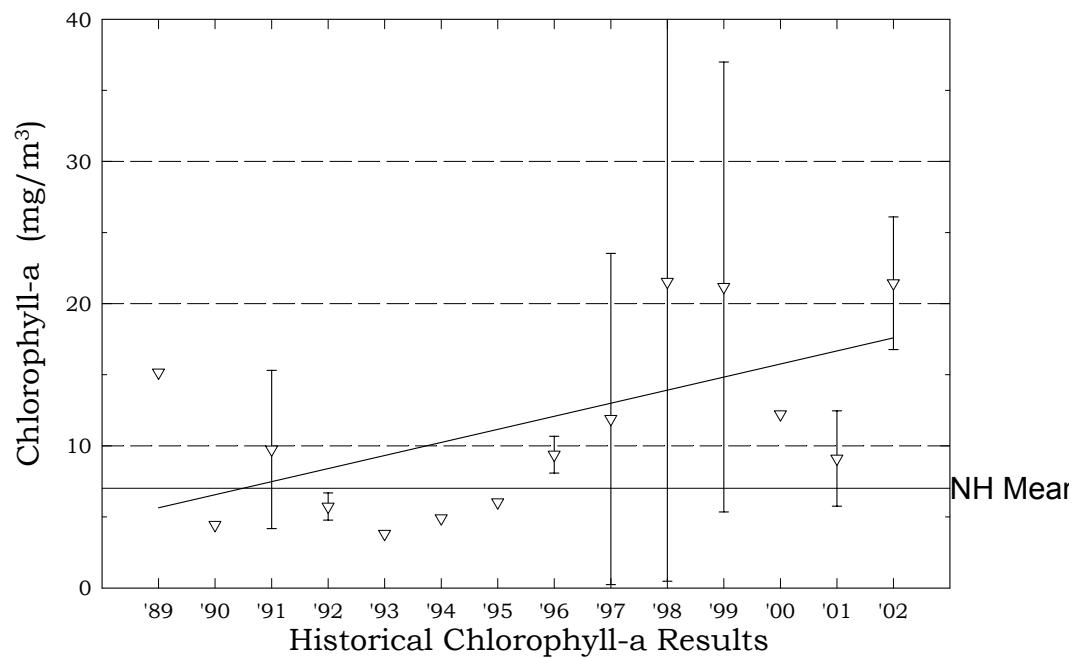
**Figure 1.** Monthly and Historical Chlorophyll-a Results

- **Figure 1 and Table 1:** The graphs in Figure 1 (Appendix A) show the historical and current year chlorophyll-a concentration in the water column. Table 1 (Appendix B) lists the maximum, minimum, and mean concentration for each sampling season that the lake/pond has been monitored through the program.

The current year data (the top graph) show that the chlorophyll-a concentration **decreased steadily** from June to September. The concentration on each sampling event was ***much greater than*** the state mean.

The historical data (the bottom graph) show that the 2002 chlorophyll-a mean is

**greater than** the state mean.

Overall, the statistical analysis of the historical data (the bottom graph) shows that the mean annual chlorophyll-a concentration has **not significantly changed** (either *continually increased* or *decreased*) since monitoring began. Specifically, the chlorophyll-a concentration has remained **varied (meaning fluctuated)** since monitoring began in 1989. (Note: Please refer to Appendix E for the detailed statistical analysis explanation and data print out.)

While algae are naturally present in all lakes/ponds, an excessive or increasing amount of any type is not welcomed. In freshwater lakes/ponds, phosphorus is the nutrient that algae depend upon for growth. Therefore, algal concentrations may increase when there is an increase in nonpoint sources of nutrient loading from the watershed, or in-lake sources of phosphorus loading (such as phosphorus releases from the sediments). It is important to continually educate residents about how activities within the watershed can affect phosphorus loading and lake quality.

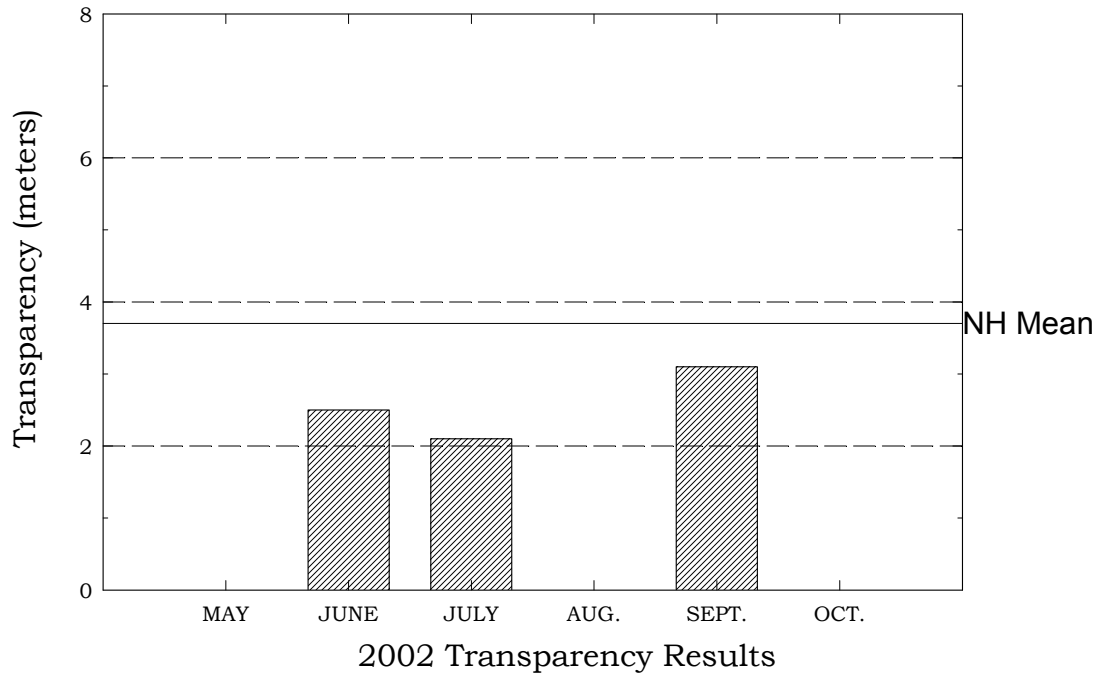
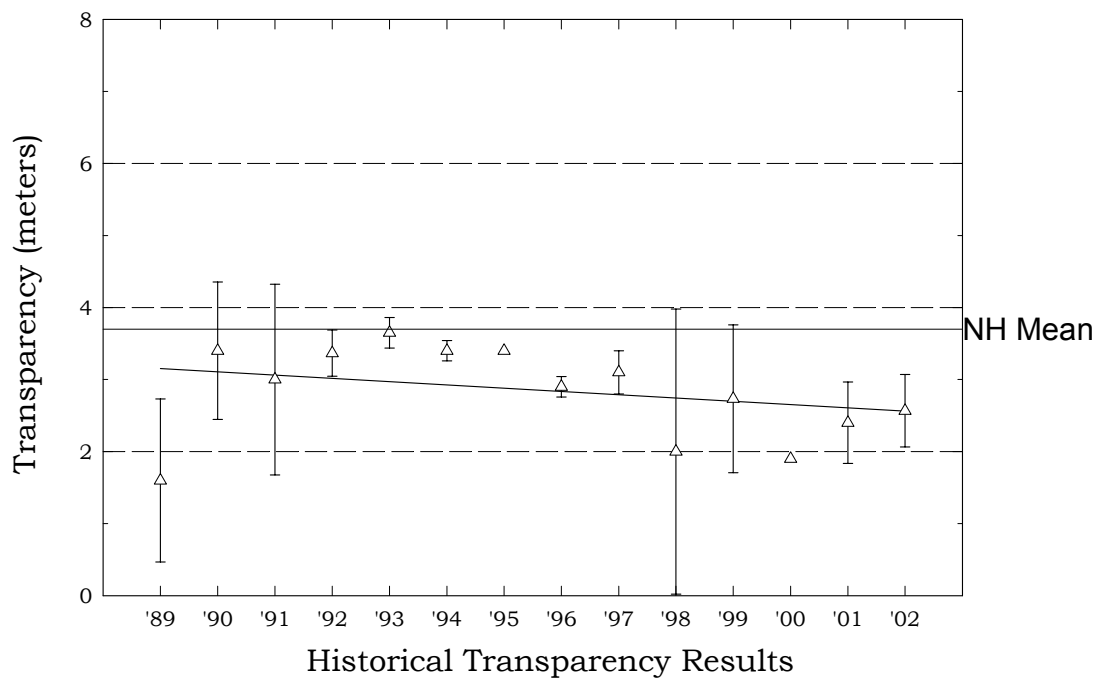
**Figure 2.** Monthly and Historical Transparency Results

- **Figure 2 and Table 3:** The graphs in Figure 2 (Appendix A) show historical and current year data for lake/pond transparency. Table 3 lists the maximum, minimum and mean transparency data for each sampling season that the lake/pond has been monitored through the program.

The current year data (the top graph) show that the in-lake transparency **decreased slightly** from June to July, and then **increased slightly** from July to September.

The historical data (the bottom graph) show that the 2002 mean transparency is **less than** the state mean.

Overall, the statistical analysis of the historical data (the bottom graph) show that the mean annual in-lake transparency has **not significantly changed** (either *continually increased* or *decreased*) since monitoring began. Specifically, the in-lake transparency has **fluctuated (meaning varied)** and has **generally been less than** the state mean. (Note: Please refer to Appendix E for the statistical analysis explanation and data print out.)

Typically, high intensity rainfall causes erosion of sediments into lakes/ponds and streams, thus decreasing clarity. Efforts should continually be made to stabilize stream banks, lake/pond shorelines, disturbed soils within the watershed, and especially dirt roads located immediately adjacent to the edge of tributaries and the lake/pond. Guides to Best Management Practices designed to reduce, and possibly even eliminate, nonpoint source pollutants, such as sediment loading, are available from NHDES upon request.

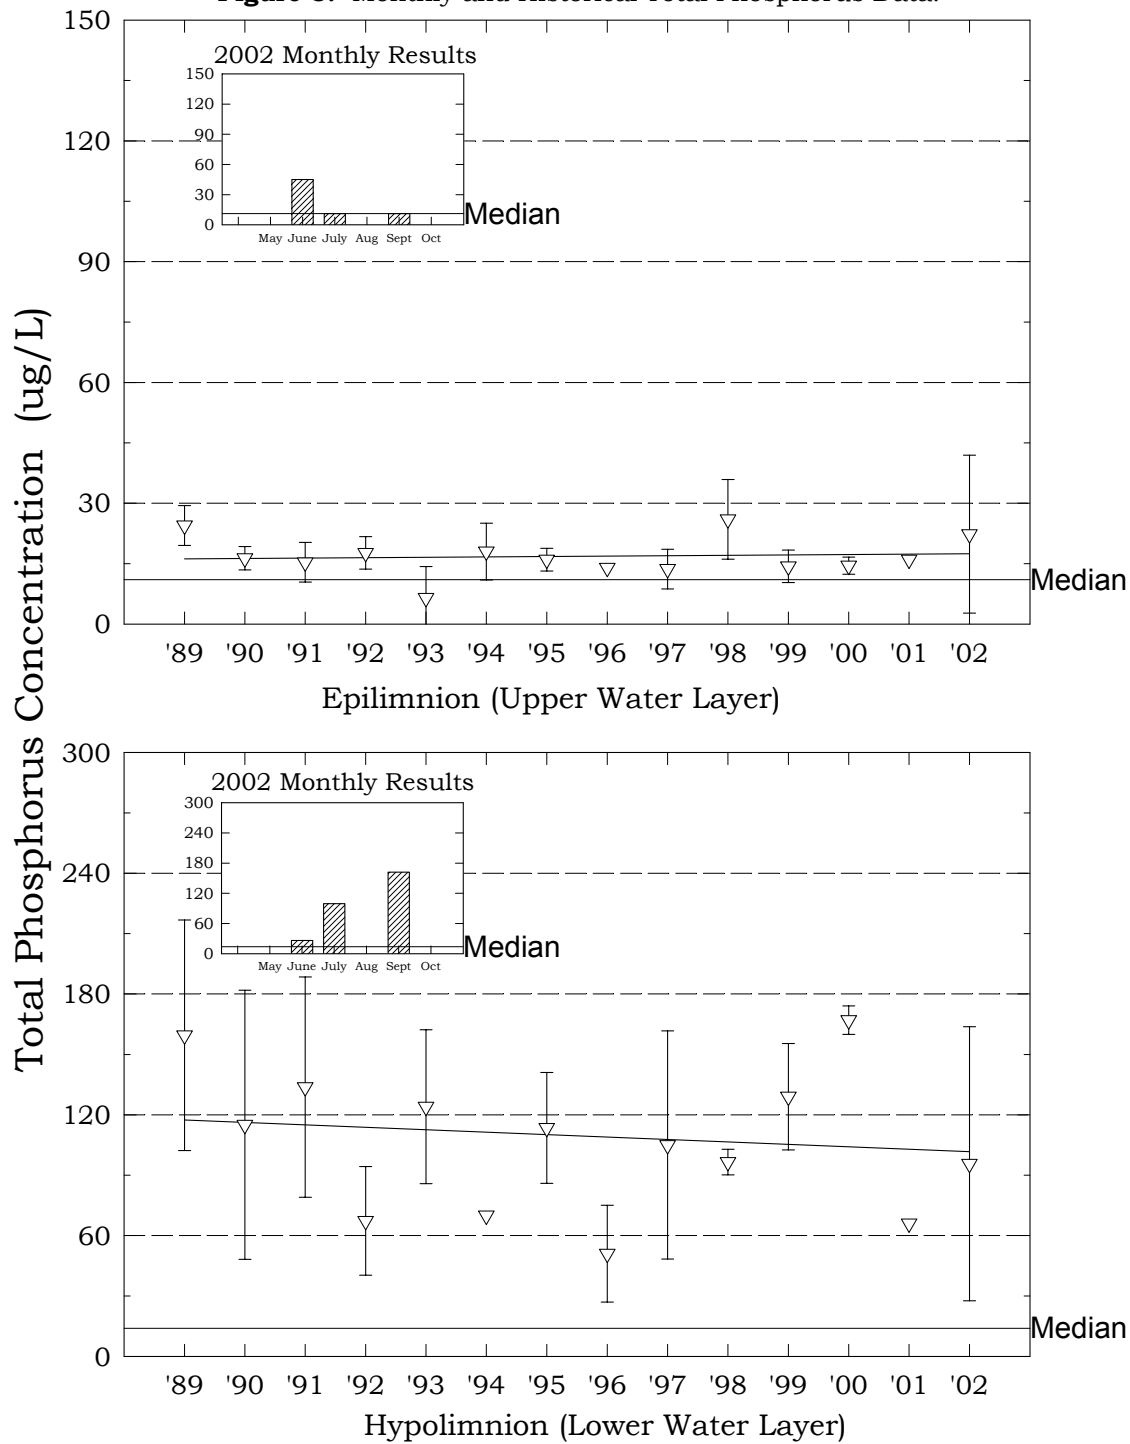
**Figure 3.** Monthly and Historical Total Phosphorus Data.

- **Figure 3 and Table 8:** The graphs in Figure 3 (Appendix A) show the amounts of phosphorus in the epilimnion (the upper layer) and the hypolimnion (the lower layer); the inset graphs show current year data. Table 8 (Appendix B) lists the annual maximum, minimum, and median concentration for each deep spot layer and each tributary since the lake/pond has joined the program.

The current year data for the epilimnion (the top inset graph) show that the total phosphorus concentration **decreased greatly** from June to July, and then **remained stable** from July to September. The total phosphorus concentration in June was **much greater than** the state median.

The historical data show that the 2002 mean epilimnetic total phosphorus concentration is **greater than** the state median.

The current year data for the hypolimnion (the bottom inset graph) show that the total phosphorus concentration **steadily increased** from June to September. The total phosphorus concentration on each sampling event was **much greater than** the state median.

It is important to note that the turbidity of the hypolimnion (lower layer) sample was elevated on the **July and September** sampling events. This suggests that the lake/pond bottom may have been disturbed by the anchor or by the Kemmerer Bottle while sampling. When the lake/pond bottom is disturbed, sediment, which typically contains attached phosphorus, is released into the water column. When collecting the hypolimnion sample, please check to make sure that there is no sediment in the Kemmerer Bottle before filling the sample bottles.

The historical data show that the 2002 mean hypolimnetic total phosphorus concentration is **much greater than** the state median.

Overall, the statistical analysis of the historical data show that the total phosphorus concentration in the epilimnion (upper layer) and the hypolimnion (lower layer) has **not significantly changed** (either *continually increased* or *decreased*) since monitoring began in 1989. Specifically, the total phosphorus concentration in the epilimnion has remained **relatively stable** and has been **slightly greater than** the state median. The total phosphorus concentration in the hypolimnion has **fluctuated greatly** and generally has been **much greater than** the state median. (Note: Please refer to Appendix E for the statistical analysis explanation and data print out.)

One of the most important approaches to reducing phosphorus loading to a waterbody is to continually educate watershed residents about its sources and how excessive amounts can adversely impact the ecology and value of lakes and ponds. Phosphorus sources within a lake or pond's watershed typically include septic systems, animal waste, lawn fertilizer, road and construction erosion, and natural wetlands. If you would like to educate watershed residents about how they can help to reduce phosphorus loading into the lake/pond, please contact the VLAP Coordinator.
